NONDESTRUCTIVE EVALUATIONS OF COM-  
POSITE HEATSHIELD MATERIALS BEFORE  
AND AFTER AN UNDERGROUND NUCLEAR  
EXPOSURE

Southern Research Institute

Air Force Weapons Laboratory

AFWL-TR-73-247

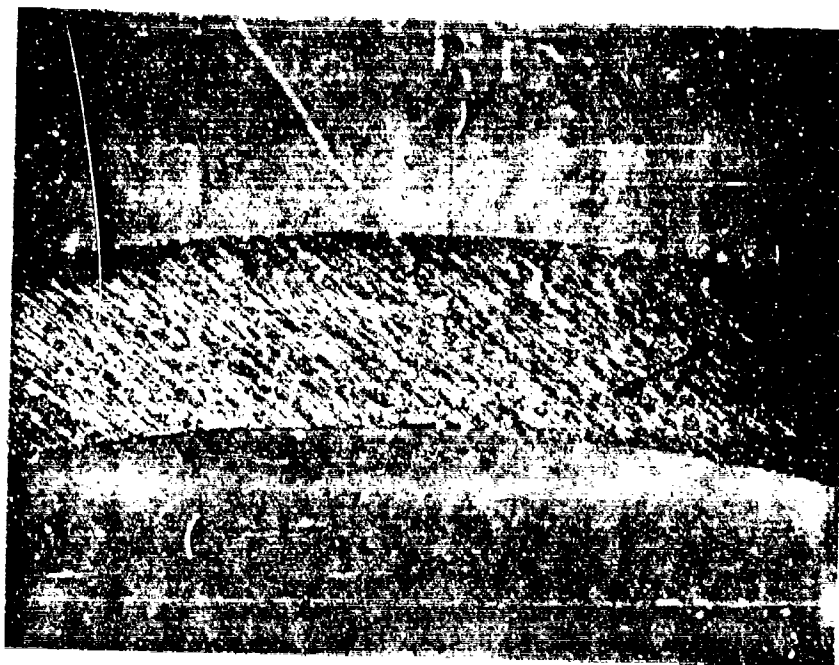
a. Axial View of Edge  
(2.7X)

Residual  
Porosity  
to 20 mils

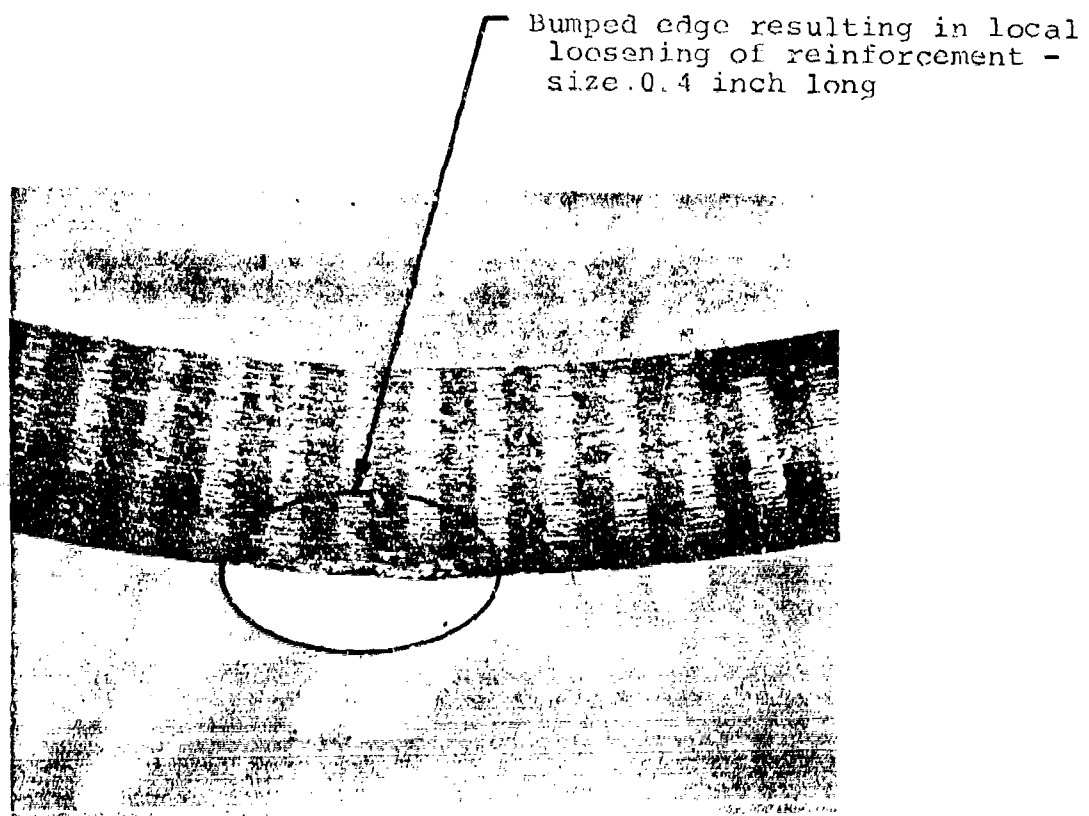
Figure 18. Photograph Showing Bumped Outer Edge  
on Ring 2 from AVCO 3DCP

Axial View - Top Edge  
(2.9X)
